# Sand Filter Repair

ID: 9534

Application: TCC-Tanks and Chemical Containment Areas

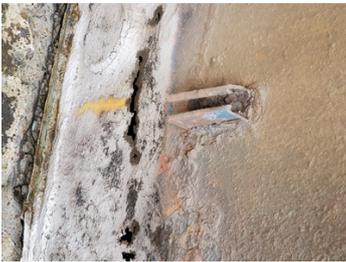
The filter tank was leaking in several areas. The base of the tank had very thin walls. It was in such bad shape it was unsafe to do the repairs from the inside.

Damage on the tank.

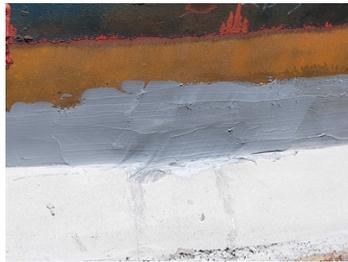
Application of Belzona 4111.

The area around the bottom of the tank was cleaned and Belzona 4111 was applied around the base of the tank. The metal was prepped any wet area we used Belzona 9611 to stop the leaks and Belzona 1161 and reinforcing cloth was used to fill in any voids and holes. then 1982 Superwrap was used around the bottom part of the tank to cover the 1161.

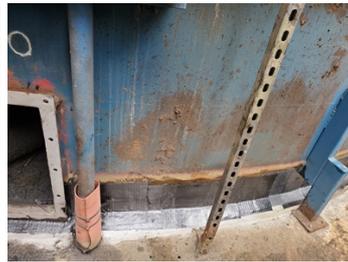
The base of the tank surface is prepped.

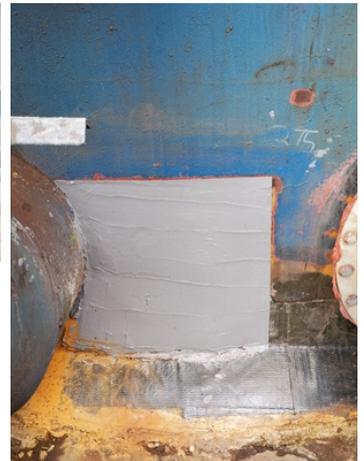
Finished application.
