Belzona rescues swimming pool pipework

Industry: Buildings & Structures
 Application: VPF-Valves, Pipes and Fittings
 Substrate: GFRP
 Products: Belzona 1161 (Super UW-Metal)

Customer Location: Nottinghamshire
 Application Date: August 2023

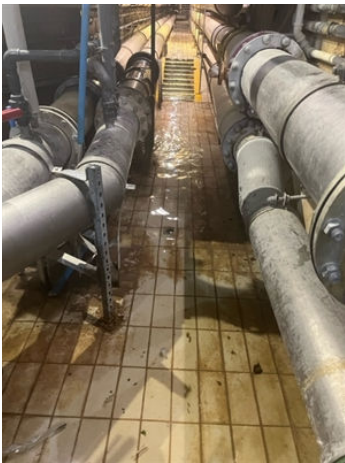
First identified

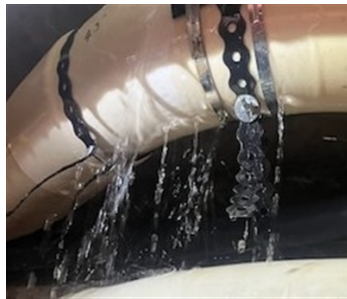
Huge amounts of water leaking from the leisure pool supply main

An estimate of over 50 litres of processed water a minute was leaking. The lost water, energy from heating it and the cleaning up process, as well as the possible damage from flooding was estimated to threaten the company with £1000's. costs.

Pipe isolated from service

Surface abraded using bristle blaster to create a rough surface

Patch secured using jubilee clips

Belzona 1161 Surface tolerant paste grade and Belzona 9341 reinforcing sheet applied

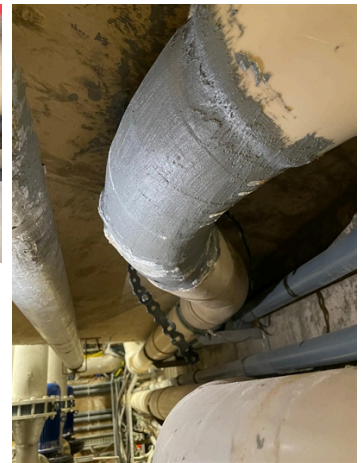
Update, 2 full years after application, showing repair still holding perfectly well.

A year on and the repair is still effective, showing no signs of leaks or water loss

Full application and reinforced wrap using Belzona 1161 and Belzona 9341 Done in August 2023
