Belzona rescues swimming pool pipework

Industry: Buildings & Structures
Application: VPF-Valves, Pipes and Fittings
Substrate: GFRP
Products: Belzona 1161 (Super UW-Metal)

Customer Location: Nottinghamshire
Application Date: August 2023

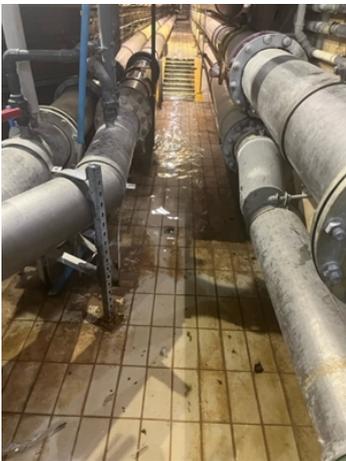
First identified

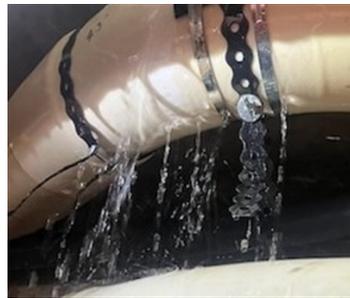
Huge amounts of water leaking from the leisure pool supply main

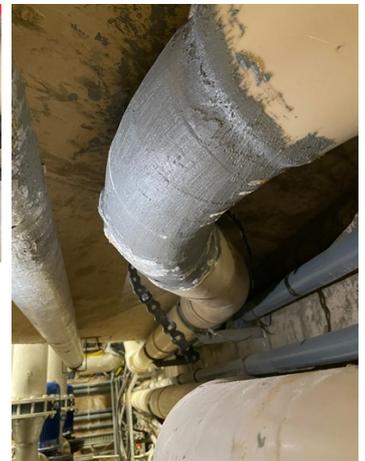
Update, 2 full years after application, showing repair still holding perfectly well.

Full application and reinforced wrap using Belzona 1161 and Belzona 9341 Done in August 2023

Pipe isolated from service

Surface abraded using bristle blaster to create a rough surface

Patch secured using jubilee clips

Belzona 1161 Surface tolerant paste grade and Belzona 9341 reinforcing sheet applied

Service pressure applied and no leaks identified
