Belzona restores Concrete Water Reservoir

Customer Location: Vancouver Island, BC

Application: TCC-Tanks and Chemical Containment Areas

Products: Belzona 4111 (Magma-Quartz), Belzona 5812 DW

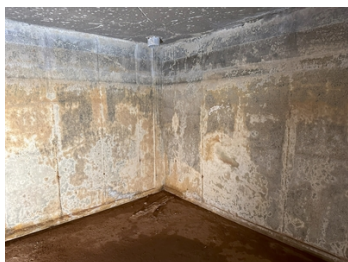
Local authorities water reservoir was leaking. Divers had entered the tank and not found the source of the leak.

Condition of the concrete once entering the tank.

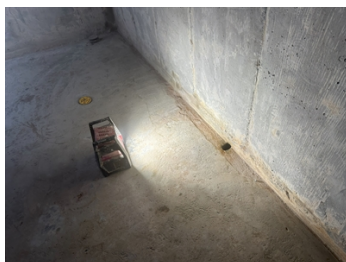
Hole located. A section of wood formwork was at grade and had deteriorated allowing the reservoir to lose a significant amount of water daily.

All surfaces were ground down using diamond cup grinders. Belzona 4111 Magma Quartz was used to seal the hole and all in perimeters were sealed. Belzona 5812DW was applied in 2 coats offering excellent protection from future decay and NSF approved as specified.

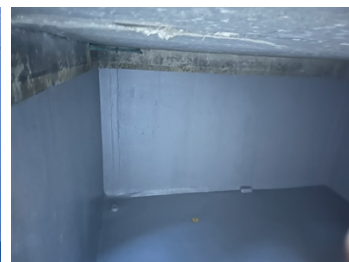
Completed 2 coats with Belzona 5812DW.
