Belzona restores Concrete Water Reservoir

Application: TCC-Tanks and Chemical Containment Areas

Products: Belzona 4111 (Magma-Quartz), Belzona 5812 DW

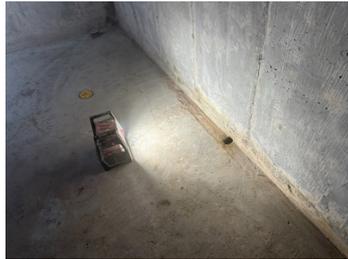
Condition of the concrete once entering the tank.

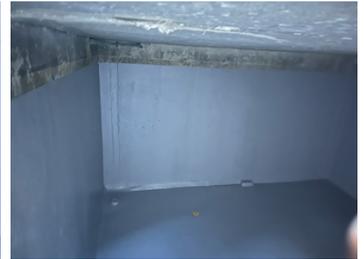
Hole sealed and 1st coat of Belzona 5812DW was applied.

All surfaces were ground down using diamond cup grinders. Belzona 4111 Magma Quartz was used to seal the hole and all in perimeters were sealed. Belzona 5812DW was applied in 2 coats offering excellent protection from future decay and NSF approved as specified.
