# Belzona restores Concrete Water Reservoir

ID: 9536

Application: TCC-Tanks and Chemical Containment Areas

Application Date: July 2024

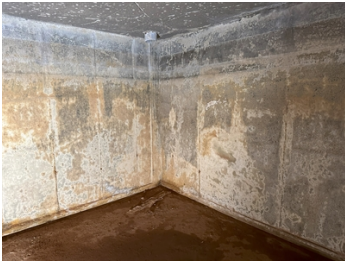
Condition of the concrete once entering the tank.

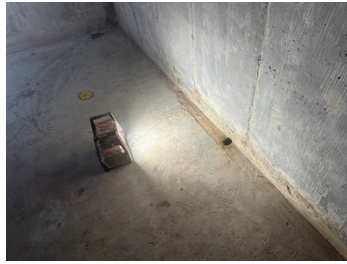
Hole located. A section of wood formwork was at grade and had deteriorated allowing the reservoir to lose a significant amount of water daily.

All surfaces were ground down using diamond cup grinders. Belzona 4111 Magma Quartz was used to seal the hole and all in perimeters were sealed. Belzona 5812DW was applied in 2 coats offering excellent protection from future decay and NSF approved as specified.
