Belzona 4311 Renovates and Protects Sulfuric Containment for Future Use

ID: 9543

Industry: Power
Application: TCC-Tanks and Chemical Containment Areas
Substrate: Concrete
Products: Belzona 4111 (Magma-Quartz), Belzona 4311 (Magma CR1), Belzona 5811 (Immersion Grade)

Customer Location: Wilsonville, AL
Application Date: September 2024

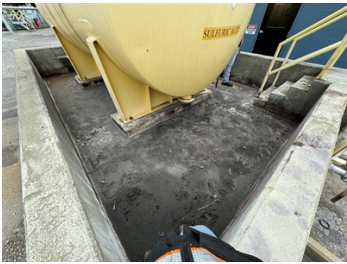
Our client's containment was facing corrosion from sulfuric acid and needed a new coating to protect the concrete secondary containment. The existing coating was buckling and there were hollow pockets underneath.

Before. Existing coating appeared not terrible but could easily be chipped away to reveal hollow concrete underneath.

The containment was first pressure washed which removed the hollow floor coating and 8" up the wall, we then followed with sand blasting where needed. Belzona 4111 was applied to the most damaged areas on the floor and walls. We also used it to build a 45 degree angle cove where the floor met the walls. Belzona 5811 was selected as the primer. We then followed with two coats of Belzona 4311.

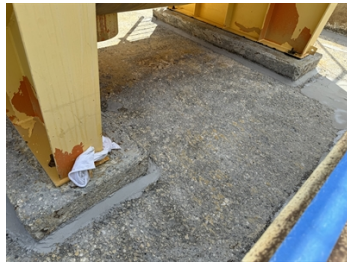
Belzona 4111 was used to build a cove around the containment and pedestals on which the tank sits. We also used on heavily damaged areas.

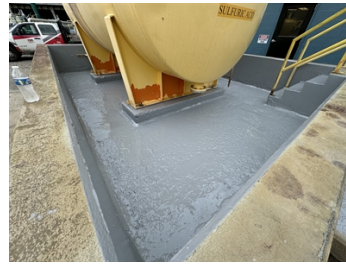
Belzona 5811 was selected as the primer coat.

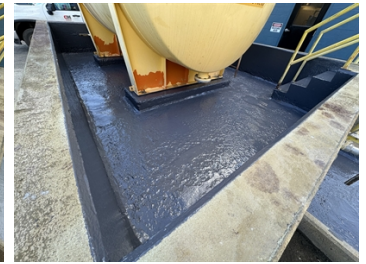
2 coats of Belzona 4311 to finish.
