Belzona 4311 Renovates and Protects Sulfuric Containment for Future Use

Industry: Power
Application: TCC-Tanks and Chemical Containment Areas
Substrate: Concrete
Products: Belzona 4111 (Magma-Quartz), Belzona 4311 (Magma CR1), Belzona 5811 (Immersion Grade)

Customer Location: Wilsonville, AL
Application Date: September 2024

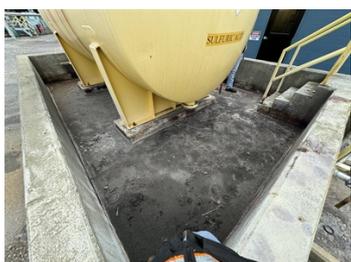
Our client's containment was facing corrosion from sulfuric acid and needed a new coating to protect the concrete secondary containment. The existing coating was buckling and there were hollow pockets underneath.

Before. Existing coating appeared not terrible but could easily be chipped away to reveal hollow concrete underneath.

The containment was first pressure washed which removed the hollow floor coating and 8" up the wall, we then followed with sand blasting where needed. Belzona 4111 was applied to the most damaged areas on the floor and walls. We also used it to build a 45 degree angle cove where the floor met the walls. Belzona 5811 was selected as the primer. We then followed with two coats of Belzona 4311.

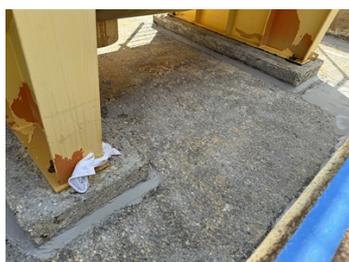
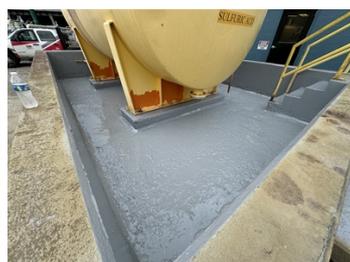
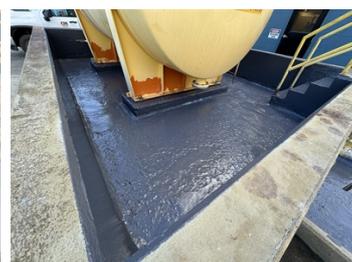
Belzona 4111 was used to build a cove around the containment and pedestals on which the tank sits. We also used on heavily damaged areas.

Belzona 5811 was selected as the primer coat.

2 coats of Belzona 4311 to finish.
