Brake test rollers

ID: 9552

Industry: *Transport*
Application: *SHM-Solids Handling Machinery*

Customer Location: *Dublin, Ireland*
Application Date: *September 2024*

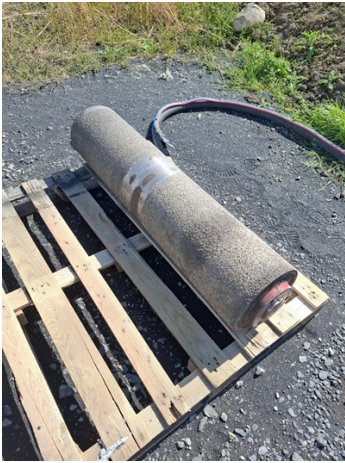
Coating had failed causing brake test rollers to lose positive grip.

Failure of previous coating

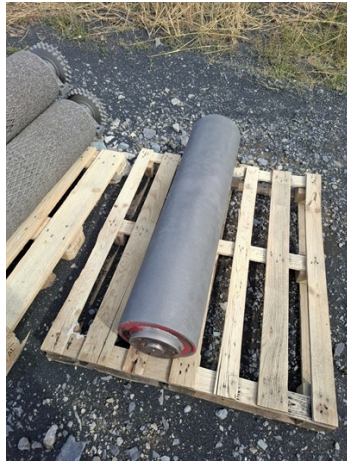
Roller grit blasted

- Rollers grit blasted to provide rough, clean surface for maximum adhesion.
- Belzona 1821 applied using short bristle brushes.
- Once the Belzona 1821 is applied, grit can be incorporated into the wet surface.
- Allow the system to cure as per the Belzona guidelines

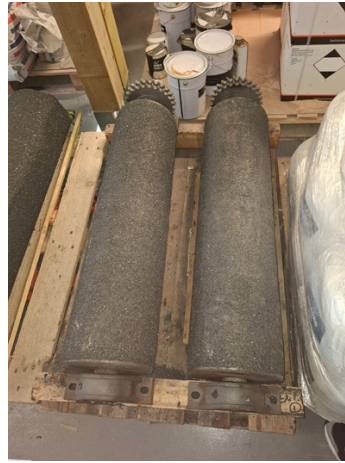
Belzona 1821 with
incorporated grit applied

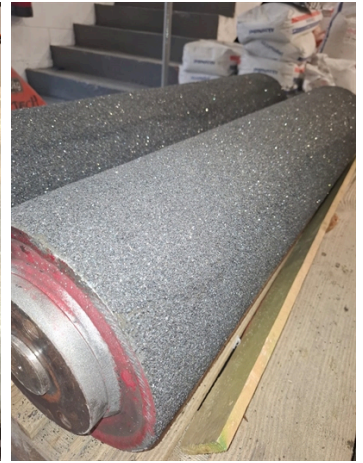
Close up of repair
