Brake test rollers

ID: 9552

Industry: *Transport*
Application: *SHM-Solids Handling Machinery*

Problem

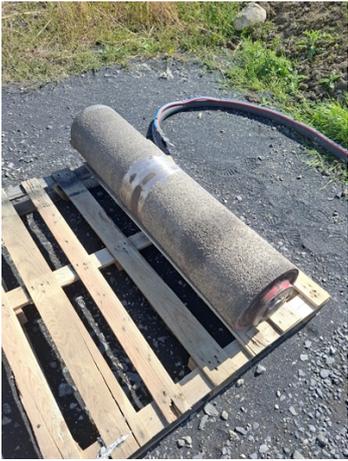
Coating had failed causing brake test rollers to lose positive grip.

Failure of previous coating

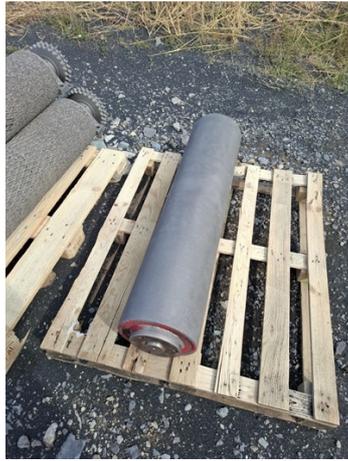
Roller grit blasted

- Rollers grit blasted to provide rough, clean surface for maximum adhesion.
- Belzona 1821 applied using short bristle brushes.
- Once the Belzona 1821 is applied, grit can be incorporated into the wet surface.
- Allow the system to cure as per the Belzona guidelines

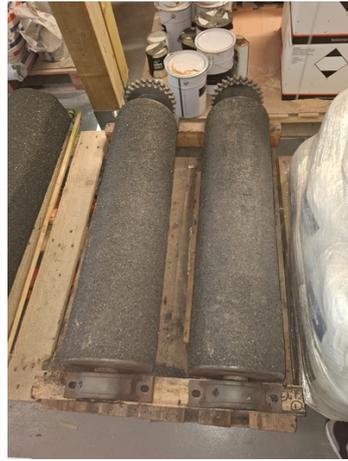
Belzona 1821 with incorporated grit applied

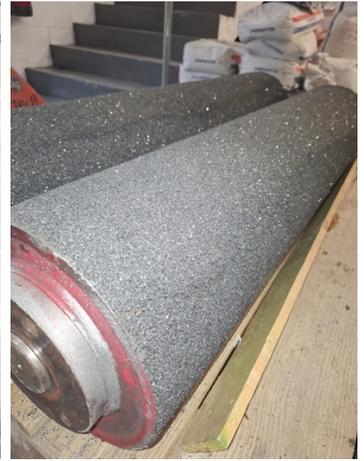
Close up of repair
