Fan housing protection

ID: 9554

Industry: *Pulp & Paper*
Application: *FBC-Fans, Blowers and Compressors*

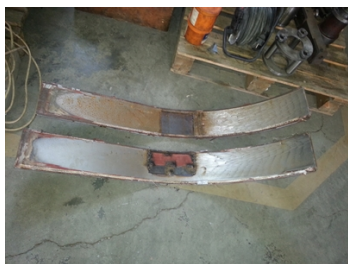
Due to the influence of wood chips, significant abrasion occurred.

Surfaces prepared before applying Belzona products.

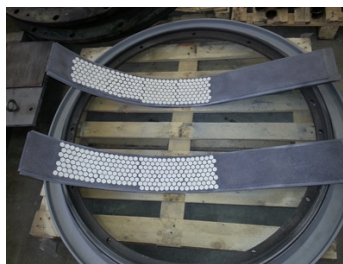
Application of Belzona 1812 and 9811 products.

Surface blasting on Sa 2.5 with 75 µm profile. Surface degreasing. Application of Belzona 1811 to a fan wheel in approx. 6000 µm thickness Application of Belzona 1812 in a thickness of approx. 6000 µm and Belzona 9811 ceramic tiles on 2 pcs of boards. Tools: spatula, roller

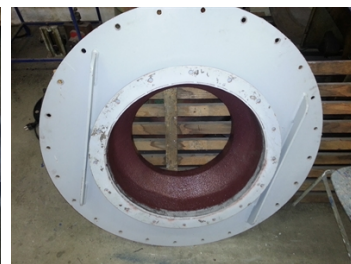
Complete application.
