Fan housing protection

ID: 9554

Industry: *Pulp & Paper*
Application: *FBC-Fans, Blowers and Compressors*

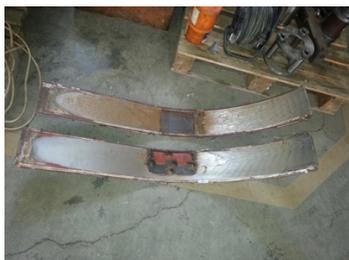
Due to the influence of wood chips, significant abrasion occurred.

Surfaces prepared before applying Belzona products.

Surface blasting on Sa 2.5 with 75 µm profile. Surface degreasing. Application of Belzona 1811 to a fan wheel in approx. 6000 µm thickness Application of Belzona 1812 in a thickness of approx. 6000 µm and Belzona 9811 ceramic tiles on 2 pcs of boards. Tools: spatula, roller

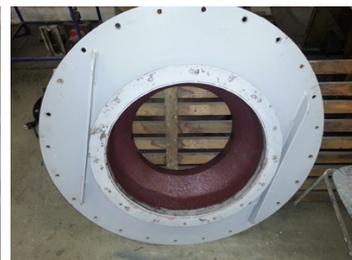
Complete application.

Fan case protection.
