# Belzona repairs forklift leak

Industry: *Pulp & Paper*  
Application: *TCC-Tanks and Chemical Containment Areas*  
Substrate: *Carbon steel*  
Products: *Belzona 1212*

Customer Location: *Castlegar*  
Application Date: *September 2024*

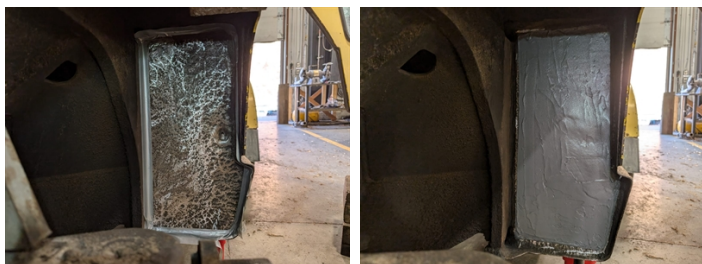
*Leak in hydraulic tank of forklift*

Prepared area

Repaired area

Leak in forklift hydraulic tank, could not use the equipment

Area prepped by hand tools and repaired with belzona 1212 and 9341
