# Caustic Tank repaired with Belzona

ID: 9560

Industry: Pulp & Paper

Application: TCC-Tanks and Chemical Containment Areas

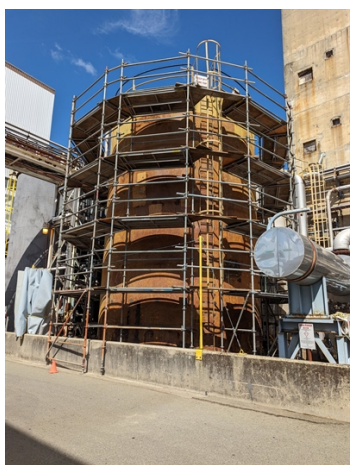
This tank was experiencing corrosion issue due to failed CUI. Areas had failed and water and contaminants came into contact with the steel tank and severe corrosion was occurring. 6 through holes were found

Tank experiencing corrosion.

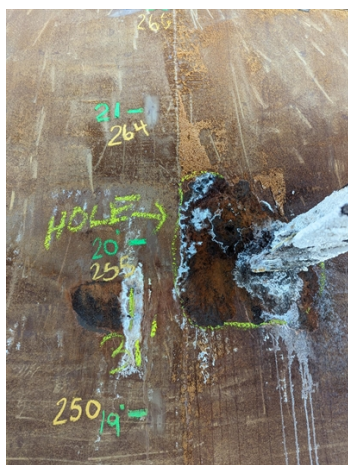
Close-up of corrosion.

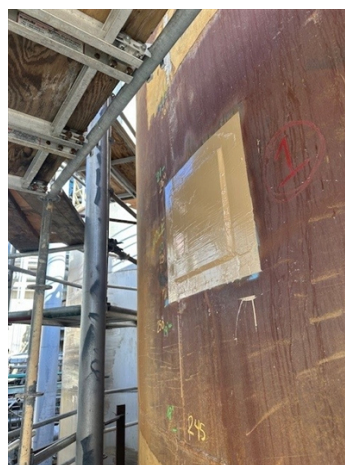
Close-up of finished application of plate bonding.

All leaks were stemmed using Belzona 9611 / 1221. Plates were bonded in place using Belzona 1111 Super Metal and then coated using Belzona 5811 immersion Grade.
