# Belzona repairs tile lining

Industry: *Pulp & Paper*

Customer Location: *Castlegar*

Application: *SHM-Solids Handling Machinery*

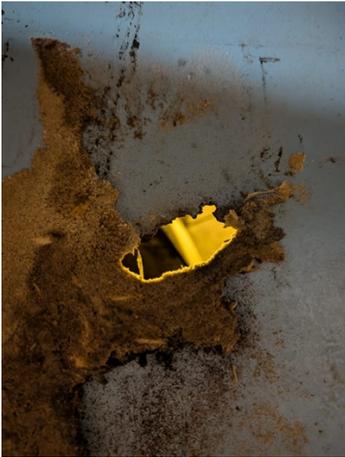
*Holes in multiple locations due to missing tiles*

One of many holes

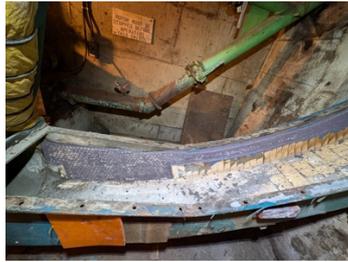
Holes repaired and tiles installed with grout

Surface mechanically prepared with hand tools, tiles bonded and grouted with Belzona

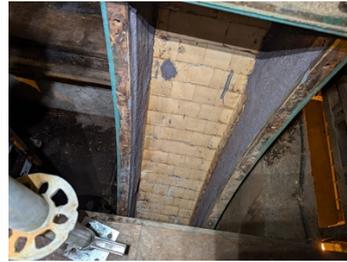
Completed application
