Belzona repairs tile lining

ID: 9562

Application: *SHM-Solids Handling Machinery*

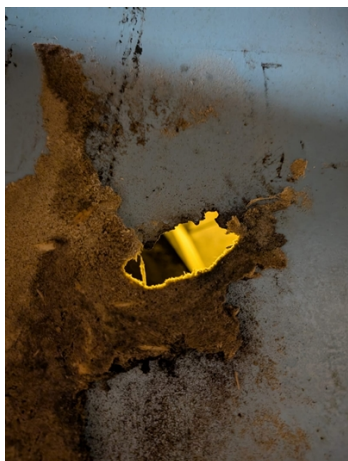
Holes in multiple locations due to missing tiles

One of many holes

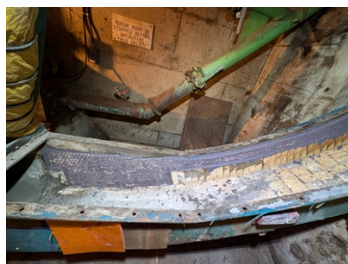
Holes repaired and tiles installed with grout

Surface mechanically prepared with hand tools, tiles bonded and grouted with Belzona

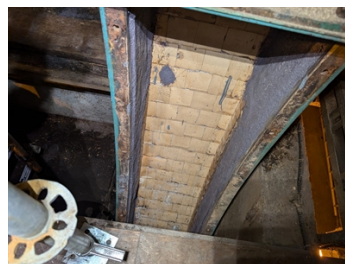
Completed application
