Belzona Relines Cooling Tower Pan

Industry: Heating, Ventilation & Air Conditioning
Application: TCC-Tanks and Chemical Containment Areas
Substrate: Carbon steel
Products: Belzona 5815

Customer Location: Nova Scotia
Application Date: May 2024

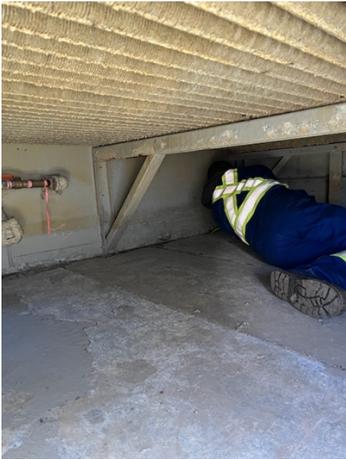
The existing coating liner was failing and required replacement.

Previous coating system.

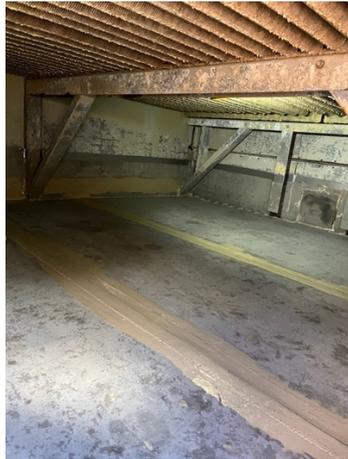
Belzona 9371 fibreglass strips wetted out with Belzona 5815 to bridge joints.

Belzona 5815 was used to wet out strips of Belzona 9371 fibreglass reinforcement to seal seams and joints. Belzona 5815 was then used as a two coat system first by applying beige as the first coat, the grey as the top coat. The Belzona 5815 coating was then cured at ambient temperatures for approximately 10 days before the cooling tower was refilled.

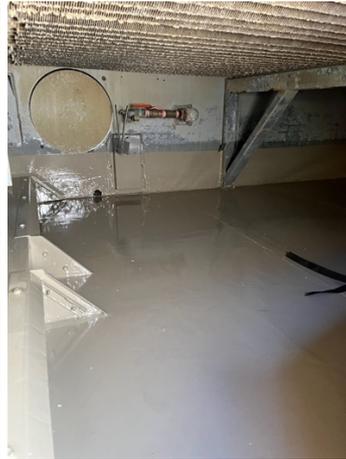
First coat of Belzona 5815 beige.

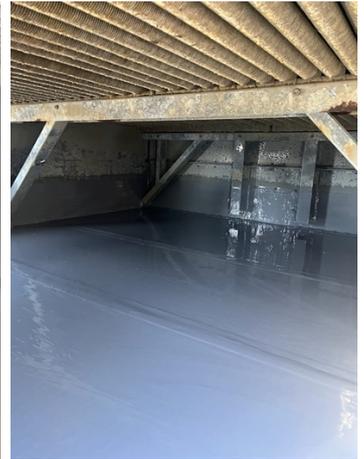
Second coat of Belzona 5815 grey.
