Repair of Irrigation Pump

ID: 9564

Industry: Other
Application: CEP-Centrifugal Pumps
Substrate: Cast Iron
Products: Belzona 1212

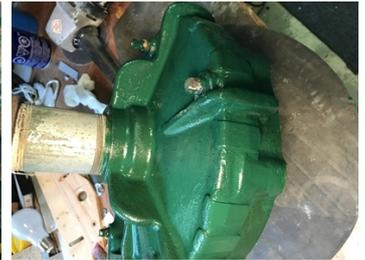
Depicts crack on pump casing.

Shows pump having had Belzona 1212 applied to the ground crack and 6 steel tabs bonded around the crack.

Inside of pump casing shows Belzona 1212 used to fill the crack and create a smooth finish for the water flow.

Belzona 1212 was applied throughout this repair. Finished job was painted.

The pump casing was hand ground along the crack. Two (2) holes were drilled to stop the crack propagation. The casing was slightly split to allow insertion of Belzona 1212, then clamped shut. The outside crack was filled with Belzona 1212, Six (6) steel tabs were bonded with Belzona 1212 to wrap the crack along its length and add strength to the repair. The pump was painted to complete the repair.
