Holes on Ship Deck Covered with Belzona.

ID: 9565

Industry: *Marine*
 Application: *FPA-Floor Problem Areas*
 Substrate: *Carbon steel*
 Products: *Belzona 1111 (Super Metal)*

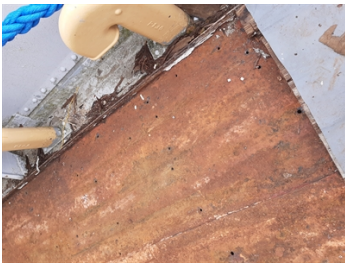
Several holes on a ship deck required patching before being sent out to the museum. Customer did not want to bond a plate to entire surface because of cost implications. Belzona 1111 was used to patch the holes individually after required surface cleaning procedure and coated afterwards.

Deck during inspection

Holes on the deck were cleaned using a power tool to the minimum surface preparation requirement. Then Belzona 1111 is mixed and applied on the deck to patch the holes.

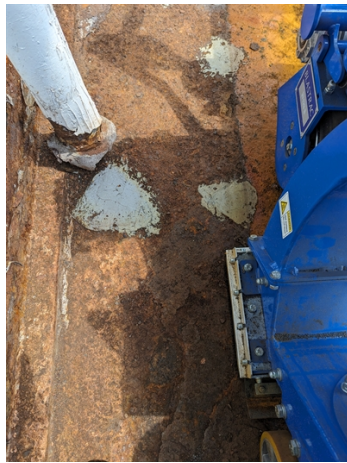
Deck after application of Belzona 1111

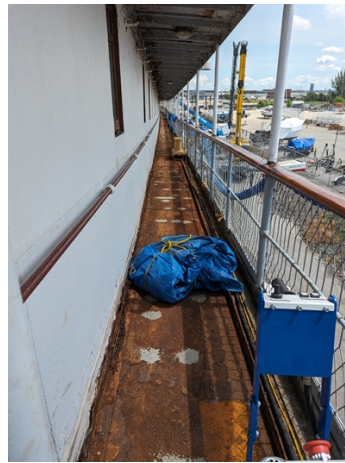
Entire deck after weeks of application,
