Holes on Ship Deck Covered with Belzona.

ID: 9565

Industry: *Marine*
 Application: *FPA-Floor Problem Areas*
 Substrate: *Carbon steel*
 Products: *Belzona 1111 (Super Metal)*

Customer Location: *Ontario*
 Application Date: *May 2023*

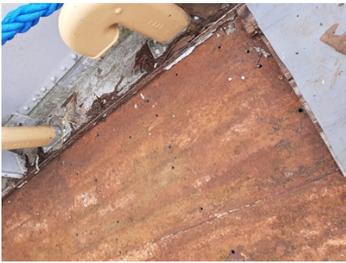
Several holes on a ship deck required patching before being sent out to the museum. Customer did not want to bond a plate to entire surface because of cost implications. Belzona 1111 was used to patch the holes individually after required surface cleaning procedure and coated afterwards.

Deck during inspection

Holes on the deck were cleaned using a power tool to the minimum surface preparation requirement. Then Belzona 1111 is mixed and applied on the deck to patch the holes.

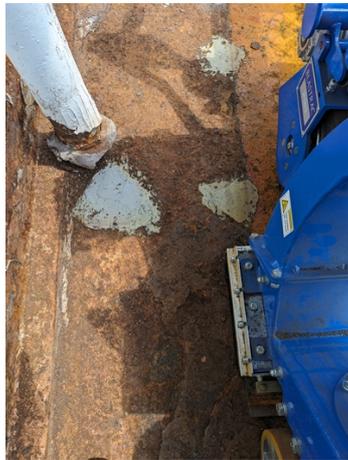
Deck after application of Belzona 1111

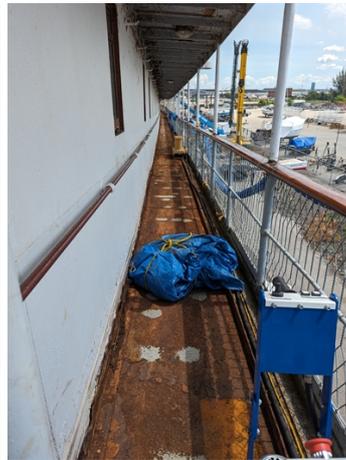
Entire deck after weeks of application,
