Rebuild and Coating of Heat Exchangers

ID: 9566

Industry: Power

Application: HEX-Heat Exchangers

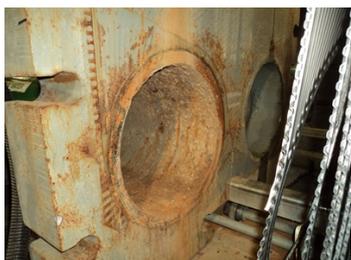
Customer was having a problem with leaking heat exchanger plates due to corrosion.

Picture shows the root cause of the issue .

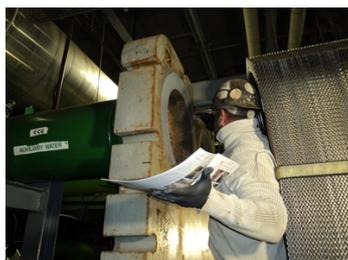
Pictures showing the application of Belzona 1111.

Power tooling was chosen for preparation was used due to no blasting inside the plant, and coating was applied with brush and rollers

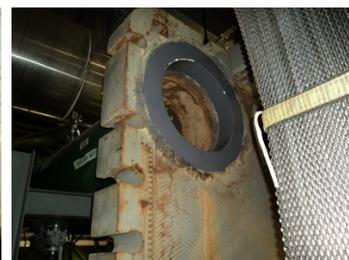
Picture showing completed application both coats of Belzona 1321.
