# Plate patch on chip chute

ID: 9567

Industry: *Pulp & Paper*  
Application: *TCC-Tanks and Chemical Containment Areas*  
Substrate: *Carbon steel*  
Products: *Belzona 1212*

Customer Location: *Castlegar*  
Application Date: *September 2024*

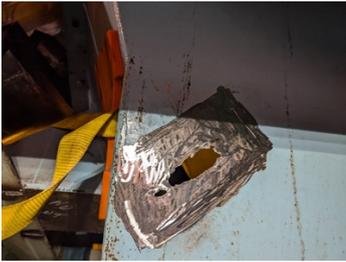
*Hole found in chip chute, causing a mess of material on the floor.*

Hole prepared for repair.

Area cleaned and degreased. Surfaces hand tool prepared, cloth and metal patch used with Belzona 1212 for long term protection.

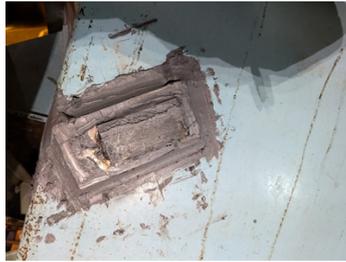
Belzona 1212 used to bond plate.

Client required immediate assistance with a home in a chip chute. Using belzona fast curing composites we were able to get them back up and running in as little as 4 hours.
