# Coal Chute Lining

ID: 9569

Industry: *Mining & Quarrying*  
Application: *SHM-Solids Handling Machinery*

Substrate: *Carbon steel*  
Products: *Belzona 1321 (Ceramic S-Metal)*

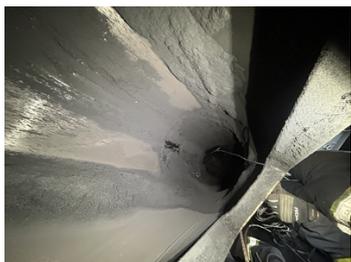
*The coal utilized in this process was sticking and plugging the chute.*

Chute prior to surface preparation.

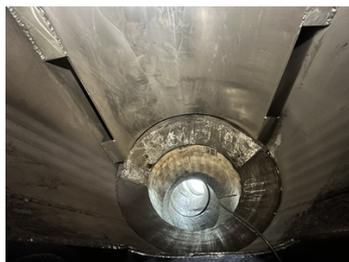
Chute after a thorough cleaning was performed.

Area cleaned and product applied following Belzona's system leaflets.

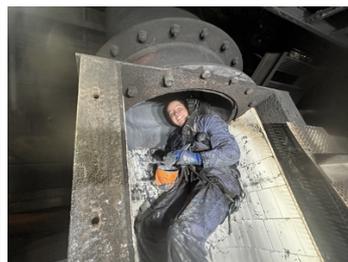
During application of Belzona 1321.

Rope rescue techniques used to safely provide a non stick coating to coal chute. Belzona helped reduce sticking of the product saving thousands in downtime.

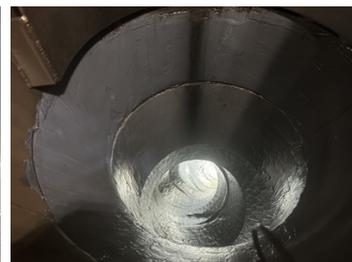
Completed application with Belzona 1321.
