Coal Chute Lining

ID: 9569

Industry: *Mining & Quarrying*
Application: *SHM-Solids Handling Machinery*

Substrate: *Carbon steel*
Products: *Belzona 1321 (Ceramic S-Metal)*

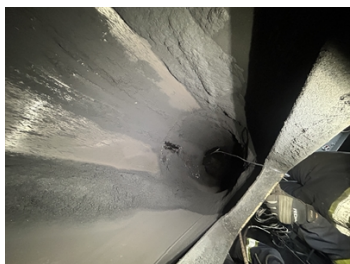
The coal utilized in this process was sticking and plugging the chute.

Chute prior to surface preparation.

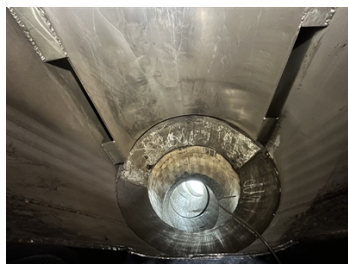
Chute after a thorough cleaning was performed.

Area cleaned and product applied following Belzona's system leaflets.

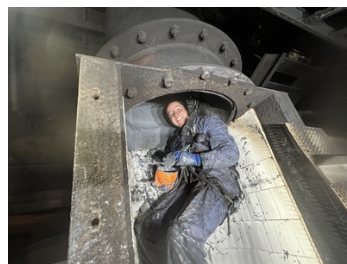
During application of Belzona 1321.

Rope rescue techniques used to safely provide a non stick coating to coal chute. Belzona helped reduce sticking of the product saving thousands in downtime.

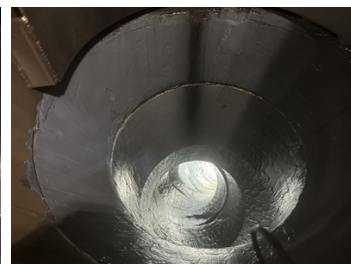
Completed application with Belzona 1321.
