# BELZONA KEEPS THE LIGHTS SHINING

Industry: Power  
Application: VPF-Valves, Pipes and Fittings  
Substrate: Porcelain and Steel  
Products: Belzona® 1161 (Super UW-Metal)

Customer Location: Primary Electricity Sub Station, UK  
Application Date: June 2006

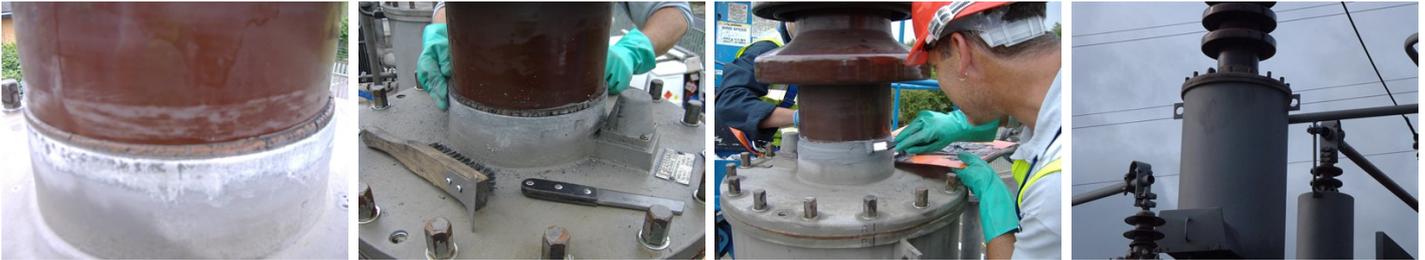
## Photograph Descriptions

Mis-alignment into steel turret occurred causing the Oil in the transformer to seep out and create a live oil leak.

\* Finding the leak , \* Preparing the substrate , \* Applying the Belzona® 1161 , \* The finished transformer in-situ ,

A Porcelain Transformer Bush was being replaced in the Substation.

Application was carried out in accordance with a modified version of Belzona Know-How System Leaflet VPF-11a.

While the transformer was being changed an emergency generator had been hired at a cost of £50,000 per week. To change the transformer would mean at least a further 4 weeks work and hire charge, assuming a spare transformer was available. Belzona repair took 12 hours at a cost of £1,000.
