BELZONA KEEPS THE LIGHTS SHINING

Industry: Power
Application: VPF-Valves, Pipes and Fittings
Substrate: Porcelain and Steel
Products: Belzona® 1161 (Super UW-Metal)

Customer Location: Primary Electricity Sub Station, UK
Application Date: June 2006

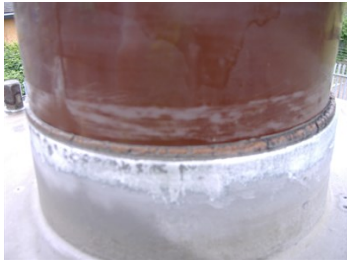
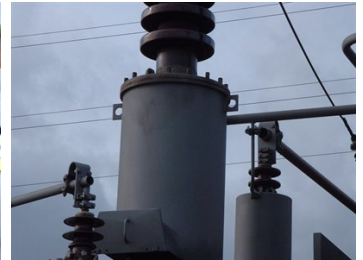
Mis-alignment into steel turret occurred causing the Oil in the transformer to seep out and create a live oil leak.

* Finding the leak , * Preparing the substrate , * Applying the Belzona® 1161 , * The finished transformer in-situ ,

Application was carried out in accordance with a modified version of Belzona Know-How System Leaflet VPF-11a.
