Feed Pellet Mill Life Extension

Application: SHM-Solids Handling Machinery

Substrate: Carbon steel

Products: Belzona 1311 (Ceramic R-Metal), Belzona 1321 (Ceramic S-Metal)

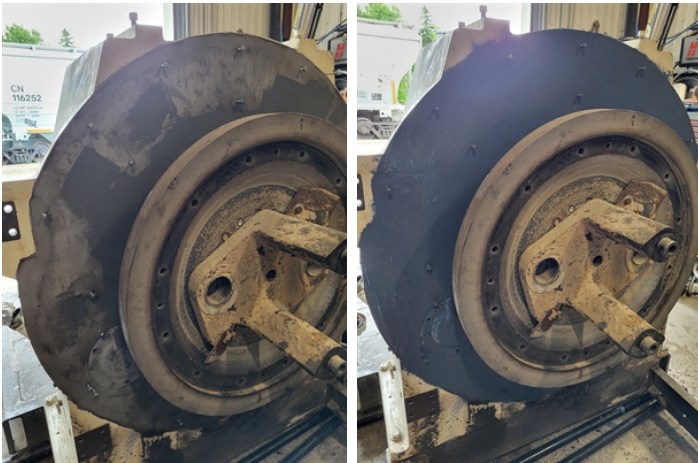
General corrosion and erosion due to long periods between maintenance cycles. Face of mill was beginning to pit badly and some temporary mounting holes needed to be plugged as was causing material to escape.

Mill face was grit blasted.
Holes and pitting were filled
with Belzona 1311

2 Coats of Belzona 1321
brushed to face to establish a
long-lasting abrasion resistant
finish suitable for the
maintenance cycle.
