Structural reinforcement of weakened pipe in a wastewater plant

ID: 9572

Application: VPF-Valves, Pipes and Fittings

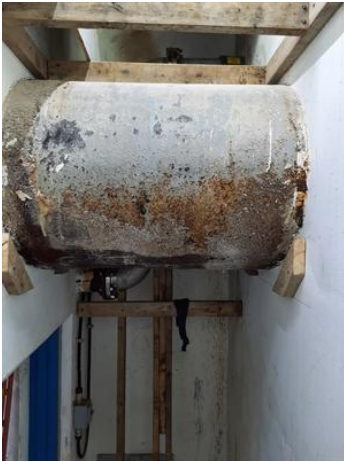
The existing pipe had become severely weakened over time and they needed to reinforce it to prevent future problems.

Defective pipe in need of reinforcement.

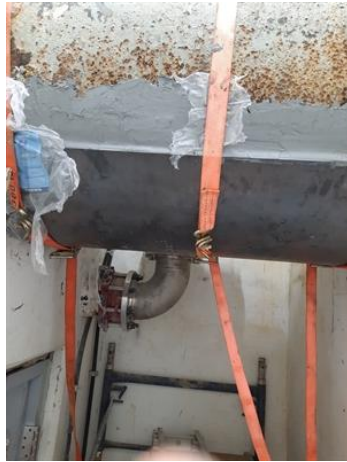
Plate bonding over the most critical area.

The substrate was prepared using power tools. Due to severe deterioration of the bottom section, we decided to add a bonded plate for extra reinforcement. Following that, we applied three wraps of Belzona for complete structural reinforcement

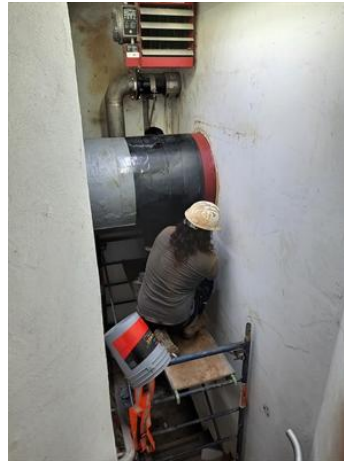
Applying SuperWrapII to strengthen the entire pipe section.
