Structural reinforcement of weakened pipe in a wastewater plant

ID: 9572

Products: Belzona 1161 (Super UW-Metal), Belzona SuperWrap II

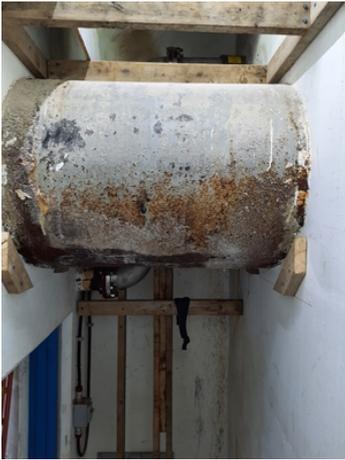
The existing pipe had become severely weakened over time and they needed to reinforce it to prevent future problems.

Defective pipe in need of reinforcement.

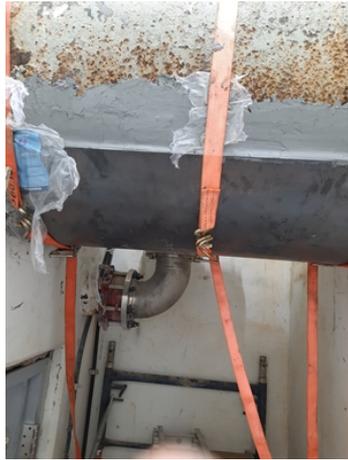
Plate bonding over the most critical area.

The substrate was prepared using power tools. Due to severe deterioration of the bottom section, we decided to add a bonded plate for extra reinforcement. Following that, we applied three wraps of Belzona for complete structural reinforcement

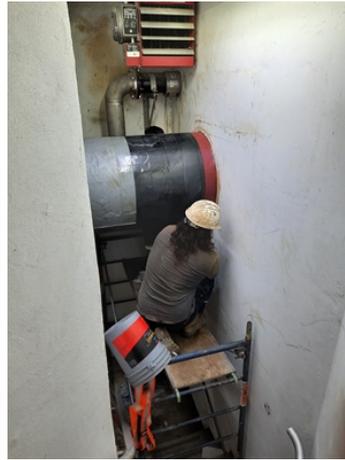
Applying SuperWrapII to strengthen the entire pipe section.
