# Relining of Cooling Water Heat exchangers

ID: 9576

**Customer Location:** Point Lepreau New Brunswick  
**Application Date:** March 2017

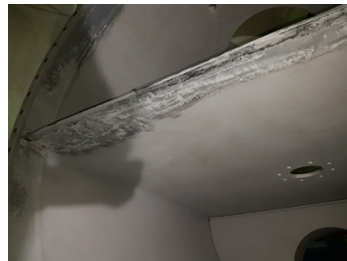
Application of Belzona 1331

Steel was abrasive blasted to SSPC SP10. Divider bar was repaired using a Belzona Applicator and a former. Lining was stripe coated by brush and two full coats applied by spray.

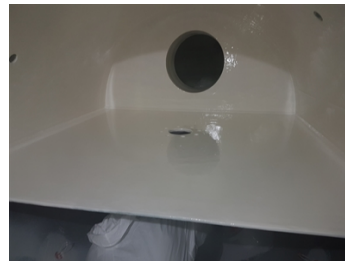
Repaired divider bar
