# Belzona protects coal chute

ID: 9579

Industry: *Mining & Quarrying*  
Application: *SHM-Solids Handling Machinery*

Substrate: *Carbon steel*  
Products: *Belzona 1331*

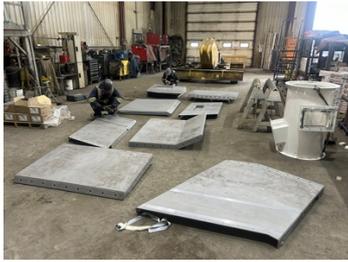
Pieces of chute grit blades in shop

Grit blast was completed, degreased all surfaces and Belzona was applied according to IFU document.

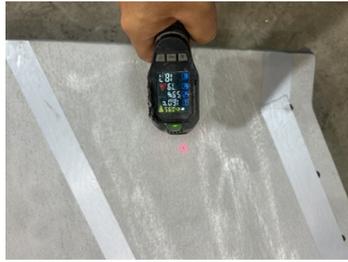
Environmental taken for QC documentation.

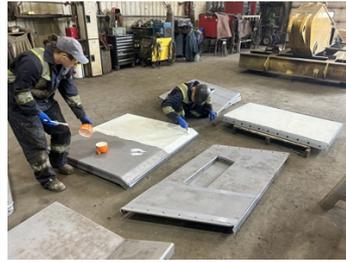
Application in progress

During a shutdown it was decided to trial Belzona on a chute liner to prevent coal sticking and downtime. Easy mixing and application made quick work of the lining areas.

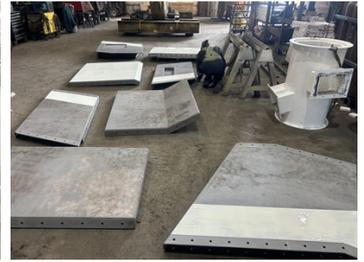
Completed application

This application has worked very well that the client is looking to have many other areas coated to prevent downtime and production stoppages.
