Drain grate for swimming pool frame gets Belzona 4111 repair

ID: 9580

Industry: Water / Wastewater
Application: FPA-Floor Problem Areas
Substrate: Masonry
Products: Belzona 4111 (Magma-Quartz)

Customer Location: Vancouver, BC
Application Date: March 2024

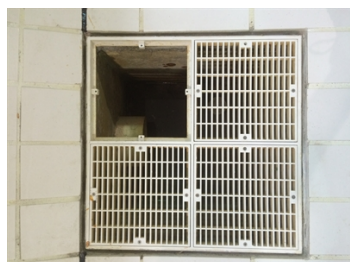
The grate perimeter seal was cracked, allowing water to migrate through and get under the tiles.

The previous product was non-existent in the cavity. Area shows that the previous product used was no longer present in the cavity.

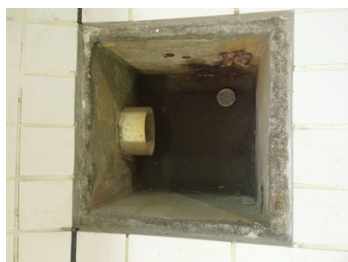
Drain cover set in place for application.

An angle grinder was used to prep the surface then Belzona conditioner and 4111 magma quartz were installed to seal and stabilize the grate.

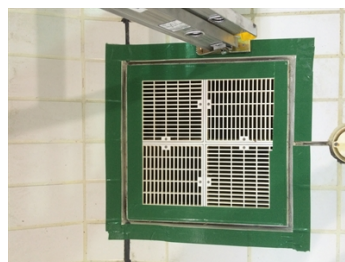
The area taped off and ready for application.

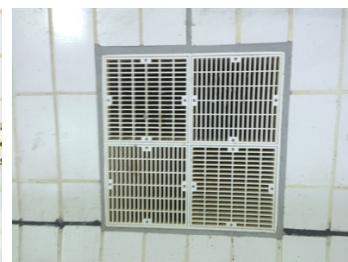
Filled and finished off using Belzona 4111.
