# Drain grate for swimming pool frame gets Belzona 4111 repair

ID: 9580

Customer Location: Vancouver, BC  
Application Date: March 2024

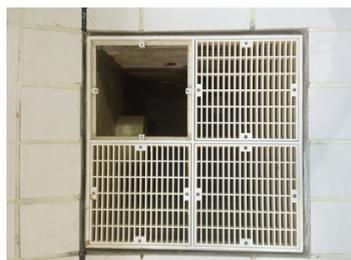
The previous product was non-existent in the cavity. Area shows that the previous product used was no longer present in the cavity.

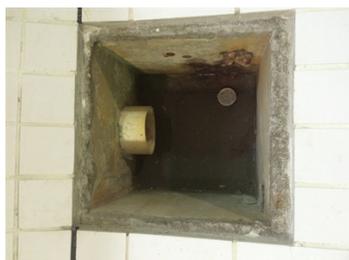
Drain cover set in place for application.

The area taped off and ready for application.

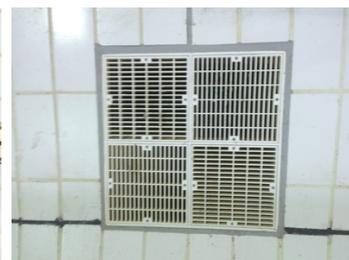
Filled and finished off using Belzona 4111.

An angle grinder was used to prep the surface then Belzona conditioner and 4111 magma quartz were installed to seal and stabilize the grate.
