Reducing Friction in Zamboni

ID: 9581

Application: SHM-Solids Handling Machinery

Products: Belzona 1341 (Supermetalglide)

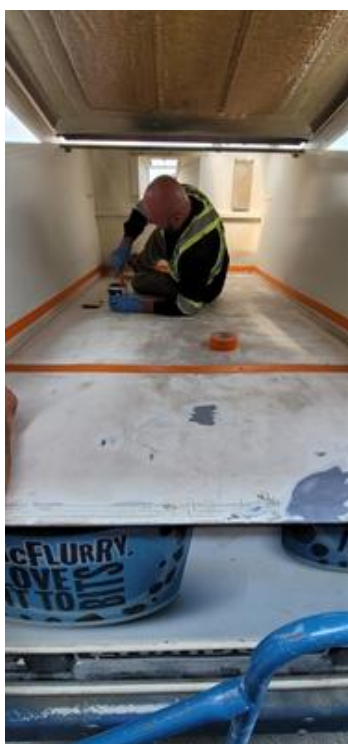
Preparing the painted aluminum surface by high grit sanding and removing all loose and overflowing sealant from edges. Taped up the wall a few inches to prevent snow sticking to them as well.

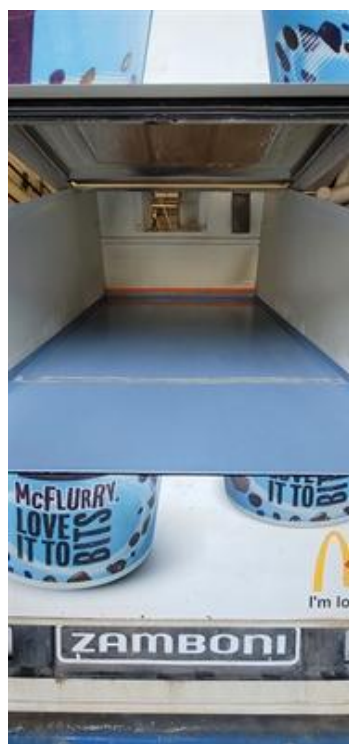
Completed surface with Belzona 1341.
