# Reducing Friction in Zamboni

ID: 9581

Industry: Local Authorities & Municipalities  
Application: SHM-Solids Handling Machinery

Substrate: Aluminum  
Products: Belzona 1341 (Supermetalglide)

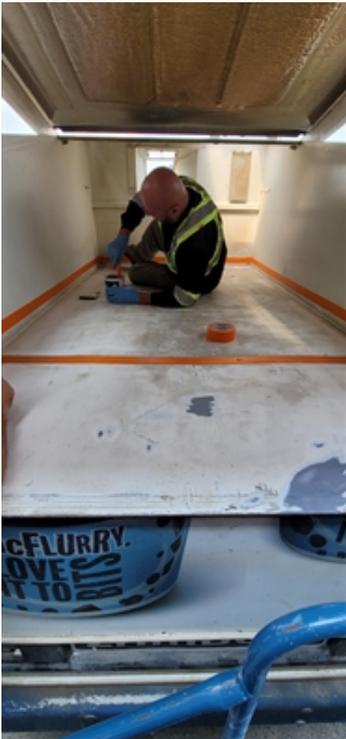
Preparing the painted aluminum surface by high grit sanding and removing all loose and overflowing sealant from edges. Taped up the wall a few inches to prevent snow sticking to them as well.

Air sanders, solvent cleanup, and brush application.

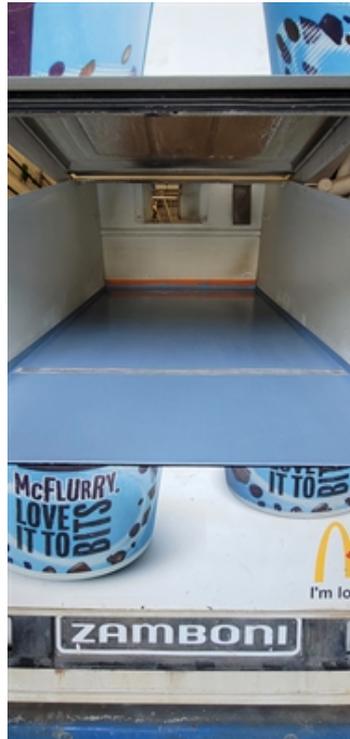
Completed surface with Belzona 1341.

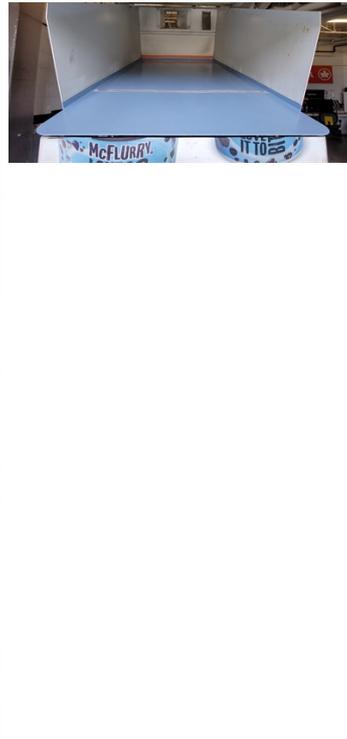
Completed surface with Belzona 1341.
