Rebuild surface and structural strength of diffuser pump component

ID: 9582

Industry: Power
Application: CEP-Centrifugal Pumps
Substrate: Cast Iron
Products: Belzona 1121 (Super XL-Metal), Belzona SuperWrap, Belzona 4111 (Magma-Quartz), Belzona 4141 (Magma-Build)

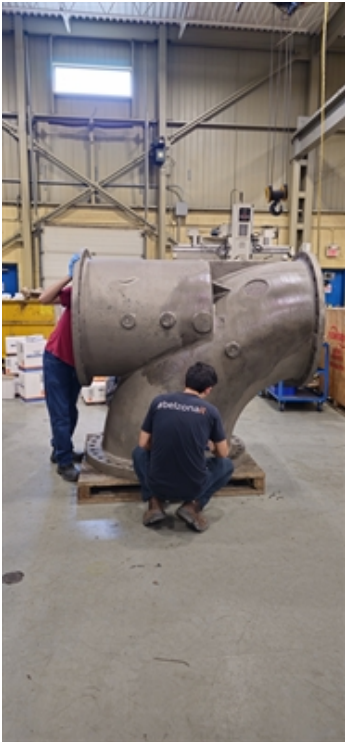
Diffuser Component

The customer experienced significant erosion issues within the diffuser pump component and, after conducting tests, determined that the structural strength of the part needed to be reinforced.

Belzona 1341 for coating inside the surface

Belzona 1341 – To address erosion-corrosion issues on the internal surfaces of the pump.

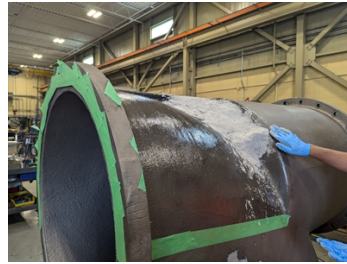
Belzona 4141 application to make a uniform shape.

Belzona 4141 – To get component in uniform shape for superwrap application.

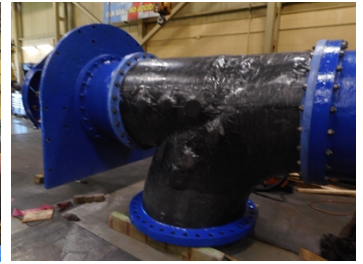
Completed work with Belzona Superwrap II

Belzona SuperWrap II (Belzona 9381, 1981, 1982) – To strengthen the structural integrity of the component.
