# Belzona replaces tile lining

ID: 9583

Application: *SHM-Solids Handling Machinery*

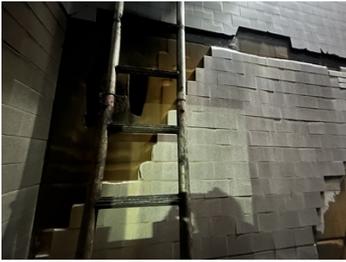
*Many damaged tiles and holes on cal reject chutes needed to be repaired.*

As found

Massive holes and damaged tile lining was found and required repair in a 48 hour period.

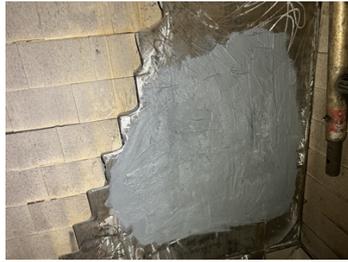
Holes repaired and ready for tile

Area prepped and holes repaired with Belzona 1311.

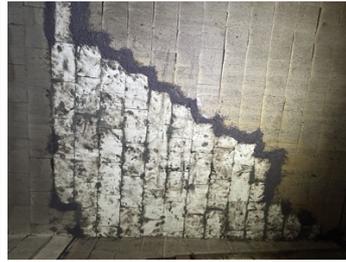
Tiles and grout completed

Belzona 1321 was used to adhere the tiles and Belzona 1812 as a grout.
