Belzona replaces tile lining

ID: 9583

Application: *SHM-Solids Handling Machinery*

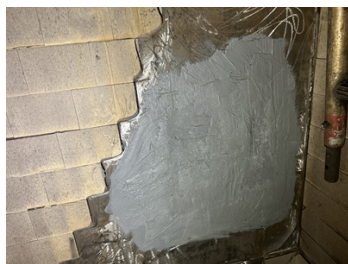
Holes repaired and ready for tile

Area prepped and holes repaired with Belzona 1311.

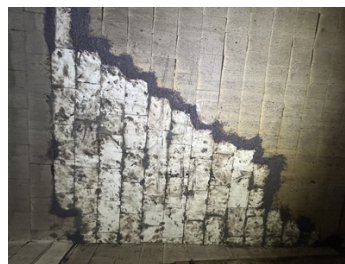
Tiles and grout completed

Belzona 1321 was used to adhere the tiles and Belzona 1812 as a grout.
