Zamboni Bay concrete restoration

ID: 9584

Industry: Local Authorities & Municipalities
Application: FPA-Floor Problem Areas
Substrate: Concrete
Products: Belzona 4111 (Magma-Quartz)

Customer Location: Campbell River, BC
Application Date: June 2024

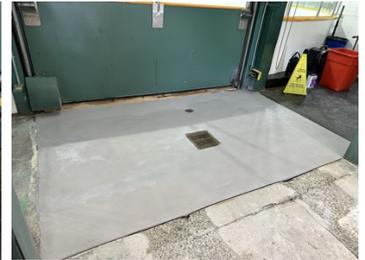
Completed application, 14 buckets of Belzona 4111 Magma Quartz were used to complete the restoration

All areas were prepared using Diamond cup grinders. Belzona 4111 Magma Quartz was applied and adequate slopes were maintained to the drains.
