# Zamboni Bay concrete restoration

ID: 9584

Industry: Local Authorities & Municipalities  
Application: FPA-Floor Problem Areas  
Substrate: Concrete  
Products: Belzona 4111 (Magma-Quartz)

Customer Location: Campbell River, BC  
Application Date: June 2024

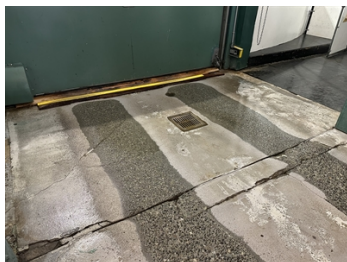
The concrete where the Zamboni exits the ice sheet was badly deteriorated and needed restoration

Condition of concrete where the Zamboni exits the ice-sheet

The customers alternative was to jackhammer out the current slab, which would of affected the operation of the rink. Our approach allowed to complete the restoration in 5 days total.

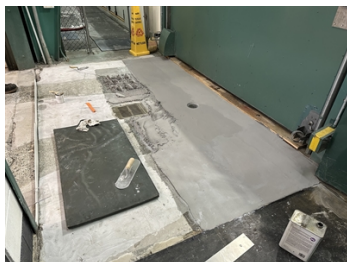
Application in progress

All areas were prepared using Diamond cup grinders. Belzona 4111 Magma Quartz was applied and adequate slopes were maintained to the drains.

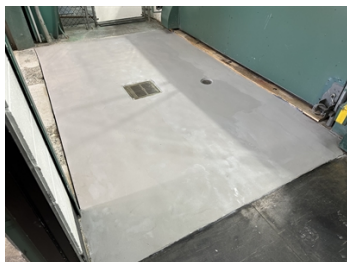
Completed application, 14 buckets of Belzona 4111 Magma Quartz were used to complete the restoration

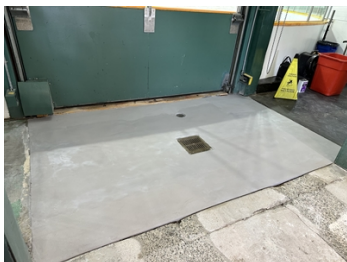
Completed application
