Furnace Air Intake Blower

ID: 9588

Application: FBC-Fans, Blowers and Compressors

Products: Belzona 1311 (Ceramic R-Metal), Belzona 1321 (Ceramic S-Metal)

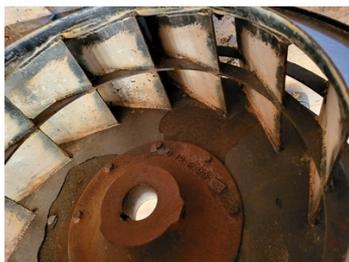
Infiltration of Perlite dust into the blower system causing very quick abrasive damage to blower fins.

Worn blower, about half way through its usual lifespan, makeshift balancing bolts.
