Furnace Air Intake Blower

ID: 9588

Application: FBC-Fans, Blowers and Compressors

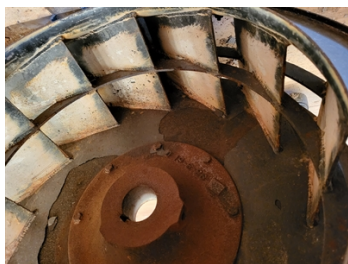
Infiltration of Perlite dust into the blower system causing very quick abrasive damage to blower fins.

Worn blower, about half way through its usual lifespan, makeshift balancing bolts.

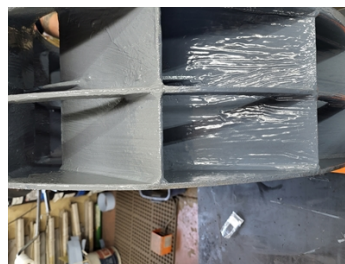
2 coats of 1321 on inside and all fins + welds. 2 colors as a wear indicator for inspection

Blower was grit blasted, plastic tool filling, brush applied coating. Baked in oven at 40C for quick return to service.
