Local Firehall

ID: 9590

Industry: *Buildings & Structures*
Application: *WPA-Wall Problem Areas*
Substrate: *Concrete*
Products: *Belzona 4111 (Magma-Quartz)*

Customer Location: *Abbotsford BC*
Application Date: *June 2022*

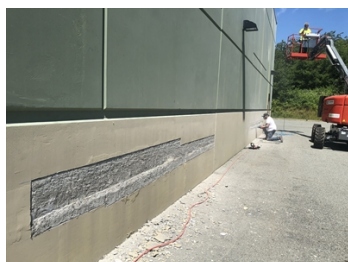
Before repainting the firehall the customer needed to make sure that the walls were repaired.

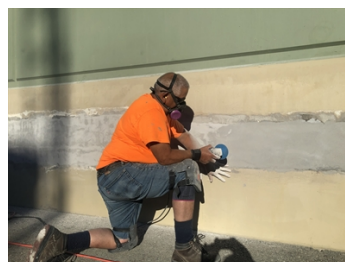
All loose areas were removed.

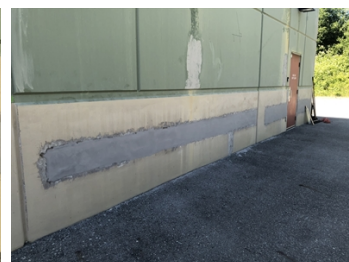
After patching the area using Belzona 4111 magma quartz an angle grinder and sanding disc were used to achieve smoothness and a good transition between the old and new coating.

Once smoothed out, the area was left for the painting crew to repaint.
