Local Firehall

ID: 9590

Industry: *Buildings & Structures*
Application: *WPA-Wall Problem Areas*
Substrate: *Concrete*
Products: *Belzona 4111 (Magma-Quartz)*

Customer Location: *Abbotsford BC*
Application Date: *June 2022*

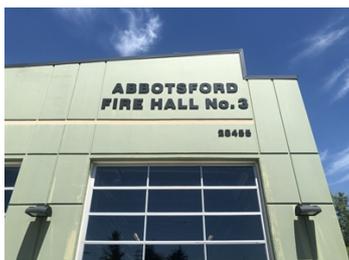
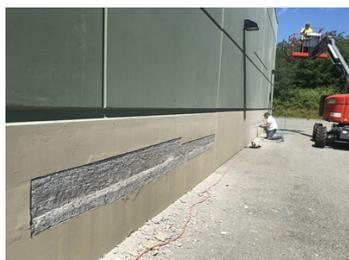
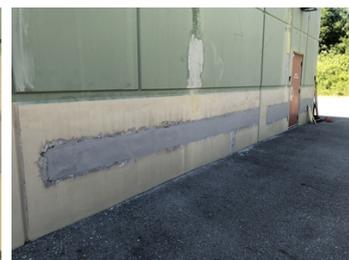
Rebar was being attacked by moisture and causing it to spall.

All loose areas were removed.

After patching the area using Belzona 4111 magma quartz an angle grinder and sanding disc were used to achieve smoothness and a good transition between the old and new coating.

Once smoothed out, the area was left for the painting crew to repaint.
