# Local Firehall

ID: 9590

Industry: Buildings & Structures  
Application: WPA-Wall Problem Areas  
Substrate: Concrete  
Products: Belzona 4111 (Magma-Quartz)

Customer Location: Abbotsford BC  
Application Date: June 2022

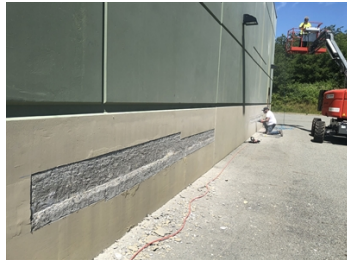
Rebar was being attacked by moisture and causing it to spall.

Before repainting the firehall the customer needed to make sure that the walls were repaired.

All loose areas were removed.

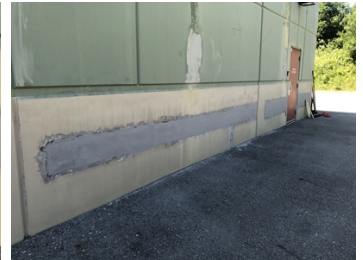
After patching the area using Belzona 4111 magma quartz an angle grinder and sanding disc were used to achieve smoothness and a good transition between the old and new coating.

Once smoothed out, the area was left for the painting crew to repaint.
