Repair Marine Seawater Cooling Pump

ID: 9591

Industry: Marine
Application: CEP-Centrifugal Pumps
Substrate: Cast Iron
Products: Belzona 1111 (Super Metal), Belzona 1212

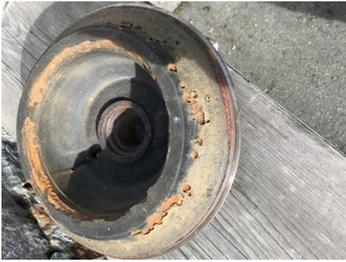
This pump casing was extremely corroded and eroded creating an unacceptable efficiency.

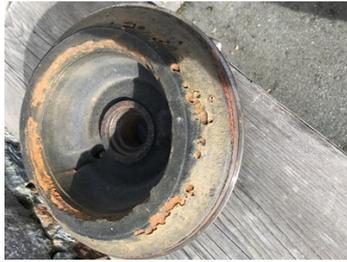
The pump casing shows more corrosion and erosion
