Belzona repairs expansion joint leak

Application: *VPF-Valves, Pipes and Fittings*

Substrate: *Stainless-steel*

Holes in an acid tank expansion joint needed to be repaired without welding.

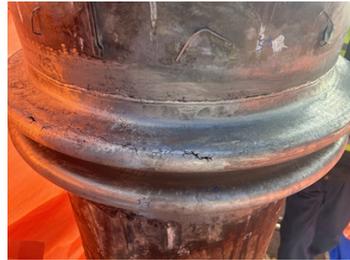
Holes found

Area cleaned and neutralized, conditioner applied followed by elastomer with reinforcement cloth.

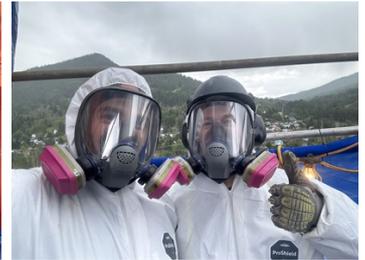
Belzona elastomer and cloth applied
