Belzona repairs expansion joint leak

ID: 9592

Application: *VPF-Valves, Pipes and Fittings*

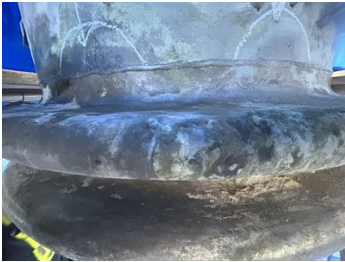
Holes in an acid tank expansion joint needed to be repaired without welding.

Holes found

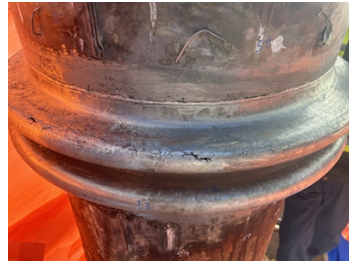
Preparation completed

Area cleaned and neutralized, conditioner applied followed by elastomer with reinforcement cloth.

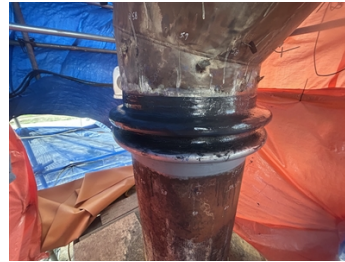
Belzona elastomer and cloth applied
