Pulp Mill's Hog Fuel Reclaim Wall repaired and protected for smooth operation

ID: 9594

Application: WPA-Wall Problem Areas

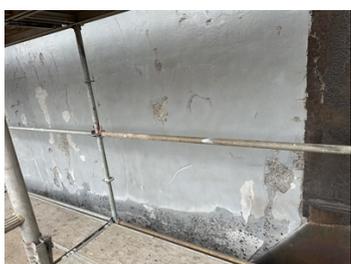
The mill load hog fuel for the boiler system. This 15-20 foot wall gets constantly loaded with hog to be sent the boiler via a conveyor system at its base. The wall was badly eroded and 'hang-ups' were occurring and this stopped the flow to the boiler. A slick finish was needed to allow the hog to slide freely to the conveyor below

Eroded and damaged wall.

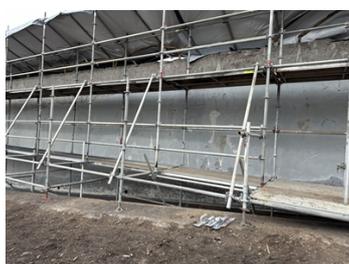
Damaged wall.

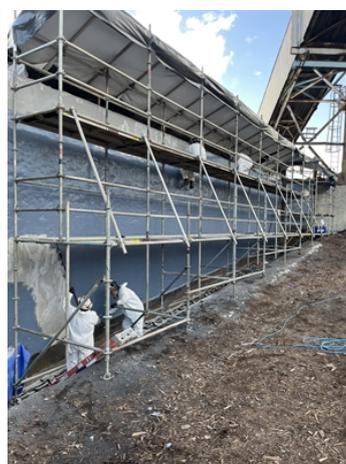
Application of Belzona 4111 to repair concrete.

Belzona 4111 was used 2/3 up the wall where the worst wear was present and two coats of Belzona 5821 Immersion Grade AR was apply.

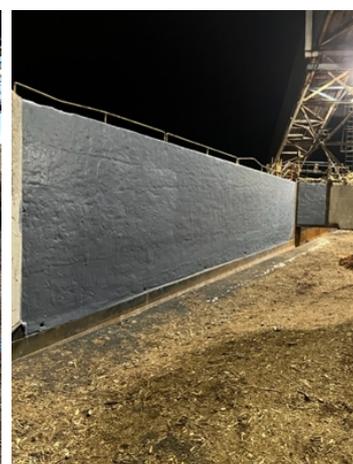
Finished application.

Other products were used and had failed in a short amount of time. The Belzona solution is working extremely well since the application
