Pulp Mill's Hog Fuel Reclaim Wall repaired and protected for smooth operation

ID: 9594

Industry:	Pulp & Paper	Customer Location:	Port Alberni, BC
Application:	WPA-Wall Problem Areas	Application Date:	April 2024
Substrate:	Concrete		
Products:	Belzona 4111 (Magma-Quartz),Belzona 5821

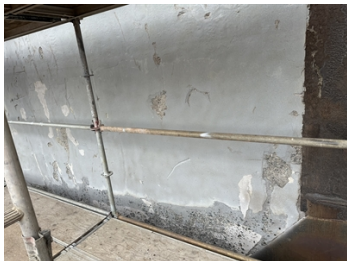
The mill load hog fuel for the boiler system. This 15-20 foot wall gets constantly loaded with hog to be sent the boiler via a conveyor system at its base. The wall was badly eroded and 'hang-ups' were occurring and thes stopped the flow to the boiler. A slick finish was needed to allow the hog to slide freely to the conveyor below

Eroded and damaged wall.

Belzona 4111 was used 2/3 up the wall where the worst wear was present and two coats of Belzona 5821 Immersion Grade AR was apply.

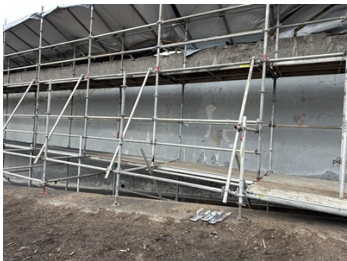
Damaged wall.

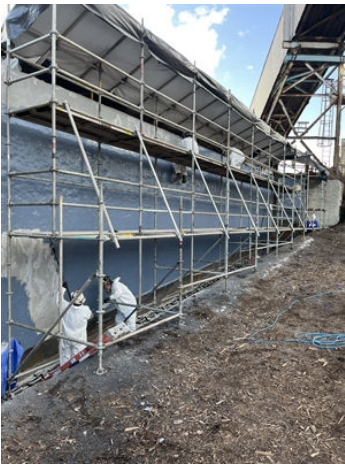
Application of Belzona 4111 to repair concrete.

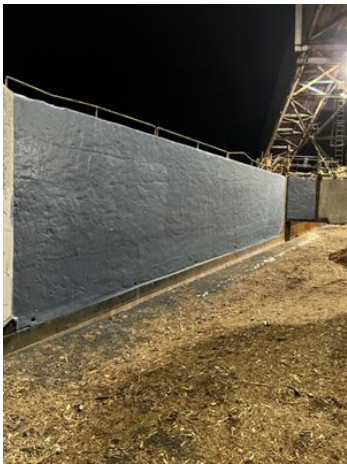
Finished application.

Other products were used and had failed in a short amount of time. The Belzona solution is working extremely well since the application
